**Flood Control Project Maintenance  
Levee Inspections**  
**LMA District Cover Sheet**  
**Spring 2018 Levee Inspection Results**

**Reclamation District No. 0108 River Farms**

**Levee Inspection Report By Mile - Spring 2018**

| Waterway | Bank | Unit Miles | Inspection Start/End | Inspector |
|---|---|---|---|---|
| Unit No. 01 Colusa Basin Drain | Left | 20.64 | 03/16/2018<br>03/16/2018 | Zach Jojola |

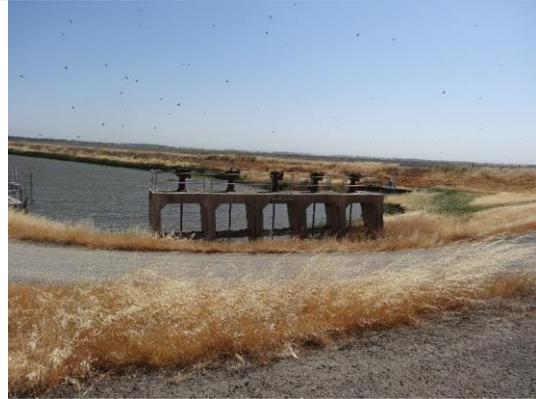
Photo 3 of 3 : UCIP\_SP\_2018\_37608\_68208.jpg

| FS_ID:37608<br>DS_ID:17943<br>EP_NO: 9396<br>Repair Type: Non-Urgent<br>Crossing Status: Found<br>UCIP Comments: Need to contact owner to determine status of structure. Notes indicate crossing has been abandoned. Owner will need to coordinate with CVFPB and DWR inspector to determine how to properly abandon.<br>FIELD_STRUCT_DESC: *ABANDONED* 1 of 5: 72-inch reinforced concrete gravity drainage pipe or culvert through the levee, 31.6 feet below the crown. Slide gate on each end. (Retention of five 72-inch pipes through the levee [HLM 0.08] authorized under Automatic Board Order (ABO) issued as Permit No. 9736, 1974 - Reclamation District No. 108 [RD0108]). [Additional Reference(s): DWR Levee Log, 1991. USACE Sacramento O&M Manual 132, October 1959, (HLM 0.08), referenced as five 6-foot by 8-foot concrete drainage culverts].<br>FS Date: 6/10/2014 | | | | | |

View of concrete structure visible on landward side.

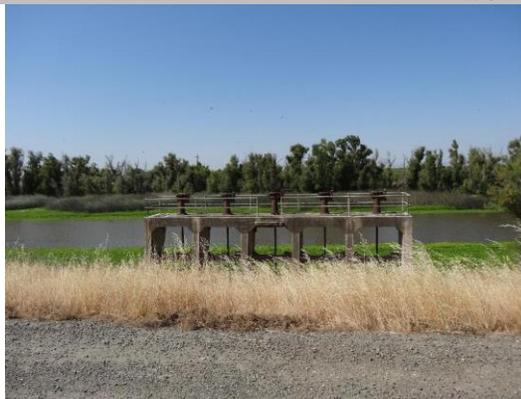
Photo 1 of 3 : UCIP\_SP\_2018\_37609\_68211.jpg

| FS_ID:37609<br>DS_ID:22386<br>EP_NO: 9396<br>Repair Type: Non-Urgent<br>Crossing Status: Found<br>UCIP Comments: Need to contact owner to determine status of structure. Notes indicate crossing has been abandoned. Owner will need to coordinate with CVFPB and DWR inspector to determine how to properly abandon.<br>FIELD_STRUCT_DESC: *ABANDONED* 2 of 5: 72-inch reinforced concrete gravity drainage pipe or culvert through the levee, 31.6 feet below the crown. Slide gate on each end. (Retention of five 72-inch pipes through the levee [HLM 0.08] authorized under Automatic Board Order (ABO) issued as Permit No. 9736, 1974 - Reclamation District No. 108 [RD0108]). [Additional Reference(s): DWR Levee Log, 1991. USACE Sacramento O&M Manual 132, October 1959, (HLM 0.08), referenced as five 6-foot by 8-foot concrete drainage culverts].<br>FS Date: 6/10/2014 | | | | | |

Concrete structure located on waterward side.

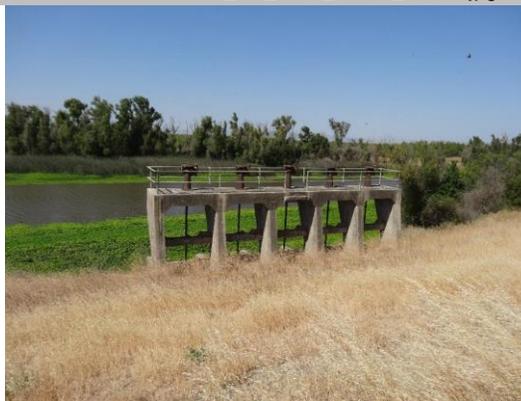
Photo 2 of 3 : UCIP\_SP\_2018\_37609\_68215.jpg

Dense vegetation covers the waterward slope.

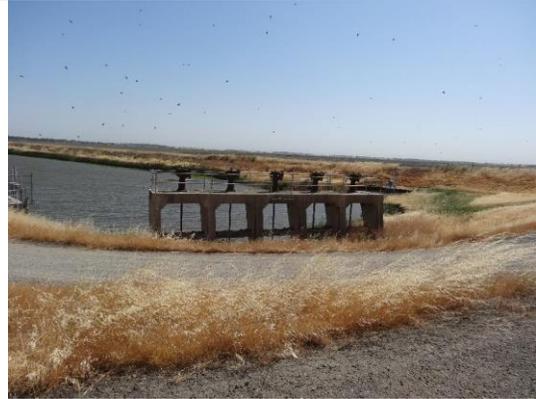
Photo 3 of 3 : UCIP\_SP\_2018\_37609\_68213.jpg

| FS_ID:37609<br>DS_ID:22386<br>EP_NO: 9396<br>Repair Type: Non-Urgent<br>Crossing Status: Found<br>UCIP Comments: Need to contact owner to determine status of structure. Notes indicate crossing has been abandoned. Owner will need to coordinate with CVFPB and DWR inspector to determine how to properly abandon.<br>FIELD_STRUCT_DESC: *ABANDONED* 2 of 5: 72-inch reinforced concrete gravity drainage pipe or culvert through the levee, 31.6 feet below the crown. Slide gate on each end. (Retention of five 72-inch pipes through the levee [HLM 0.08] authorized under Automatic Board Order (ABO) issued as Permit No. 9736, 1974 - Reclamation District No. 108 [RD0108]). [Additional Reference(s): DWR Levee Log, 1991. USACE Sacramento O&M Manual 132, October 1959, (HLM 0.08), referenced as five 6-foot by 8-foot concrete drainage culverts].<br>FS Date: 6/10/2014 | | | | | |

View of concrete structure located on landward side.

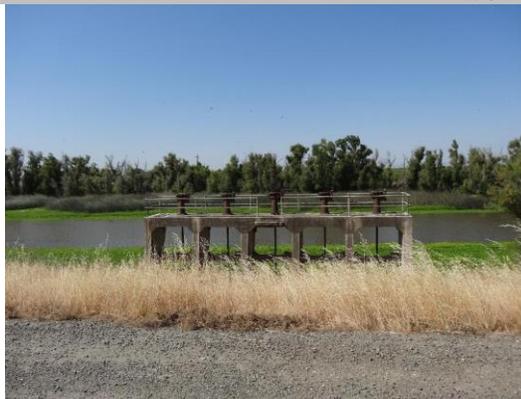
Photo 1 of 3 : UCIP\_SP\_2018\_37610\_68216.jpg

| FS_ID:37610<br>DS_ID:22387<br>EP_NO: 9396<br>Repair Type: Non-Urgent<br>Crossing Status: Found<br>UCIP Comments: Need to contact owner to determine status of structure. Notes indicate crossing has been abandoned. Owner will need to coordinate with CVFPB and DWR inspector to determine how to properly abandon.<br>FIELD_STRUCT_DESC: *ABANDONED* 3 of 5: 72-inch reinforced concrete gravity drainage pipe or culvert through the levee, 31.6 feet below the crown. Slide gate on each end. (Retention of five 72-inch pipes through the levee [HLM 0.08] authorized under Automatic Board Order (ABO) issued as Permit No. 9736, 1974 - Reclamation District No. 108 [RD0108]). [Additional Reference(s): DWR Levee Log, 1991. USACE Sacramento O&M Manual 132, October 1959, (HLM 0.08), referenced as five 6-foot by 8-foot concrete drainage culverts].<br>FS Date: 6/10/2014 | | | | | |

Concrete structure located on waterward side.

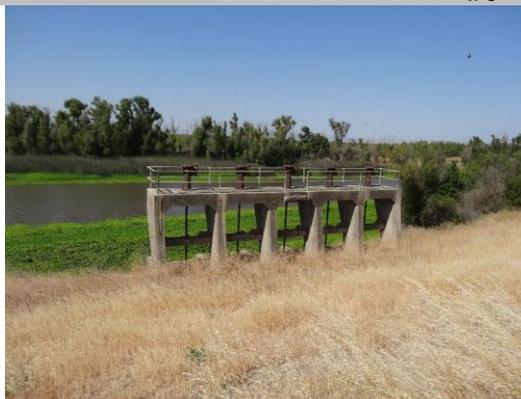
Photo 2 of 3 : UCIP\_SP\_2018\_37610\_68219.jpg

Dense vegetation covers waterward side slope.

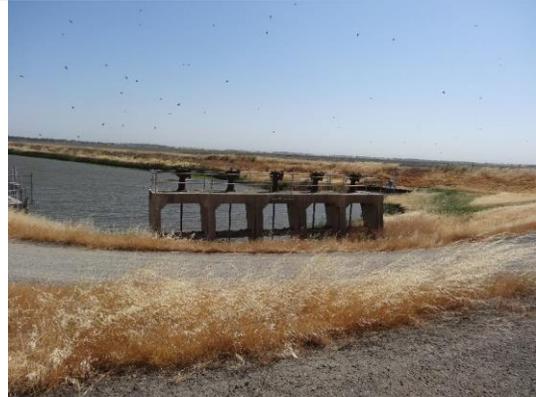
Photo 3 of 3 : UCIP\_SP\_2018\_37610\_68217.jpg

| FS_ID:37610<br>DS_ID:22387<br>EP_NO: 9396<br>Repair Type: Non-Urgent<br>Crossing Status: Found<br>UCIP Comments: Need to contact owner to determine status of structure. Notes indicate crossing has been abandoned. Owner will need to coordinate with CVFPB and DWR inspector to determine how to properly abandon.<br>FIELD_STRUCT_DESC: *ABANDONED* 3 of 5: 72-inch reinforced concrete gravity drainage pipe or culvert through the levee, 31.6 feet below the crown. Slide gate on each end. (Retention of five 72-inch pipes through the levee [HLM 0.08] authorized under Automatic Board Order (ABO) issued as Permit No. 9736, 1974 - Reclamation District No. 108 [RD0108]). [Additional Reference(s): DWR Levee Log, 1991. USACE Sacramento O&M Manual 132, October 1959, (HLM 0.08), referenced as five 6-foot by 8-foot concrete drainage culverts].<br>FS Date: 6/10/2014 | | | | | |

Concrete structure located on landward side.

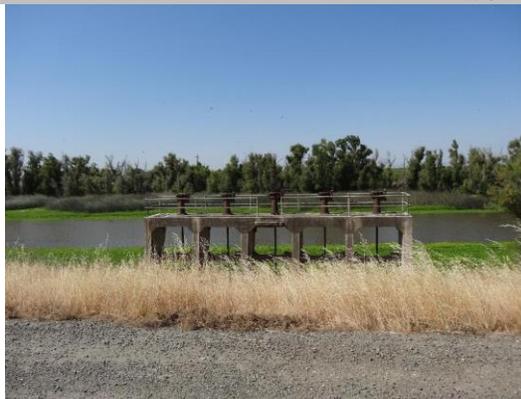
Photo 1 of 3 : UCIP\_SP\_2018\_37611\_68220.jpg

| FS_ID:37611<br>DS_ID:22388<br>EP_NO: 9396<br>Repair Type: Non-Urgent<br>Crossing Status: Found<br>UCIP Comments: Need to contact owner to determine status of structure. Notes indicate crossing has been abandoned. Owner will need to coordinate with CVFPB and DWR inspector to determine how to properly abandon.<br>FIELD_STRUCT_DESC: *ABANDONED* 4 of 5: 72-inch reinforced concrete gravity drainage pipe or culvert through the levee, 31.6 feet below the crown. Slide gate on each end. (Retention of five 72-inch pipes through the levee [HLM 0.08] authorized under Automatic Board Order (ABO) issued as Permit No. 9736, 1974 - Reclamation District No. 108 [RD0108]). [Additional Reference(s): DWR Levee Log, 1991. USACE Sacramento O&M Manual 132, October 1959, (HLM 0.08), referenced as five 6-foot by 8-foot concrete drainage culverts].<br>FS Date: 6/10/2014 | | | | | |

Concrete structure located on waterward side.

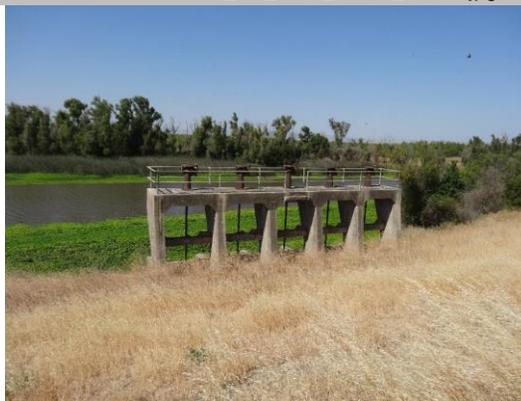
Photo 2 of 3 : UCIP\_SP\_2018\_37611\_68224.jpg

Waterward slope covered by dense vegetation.

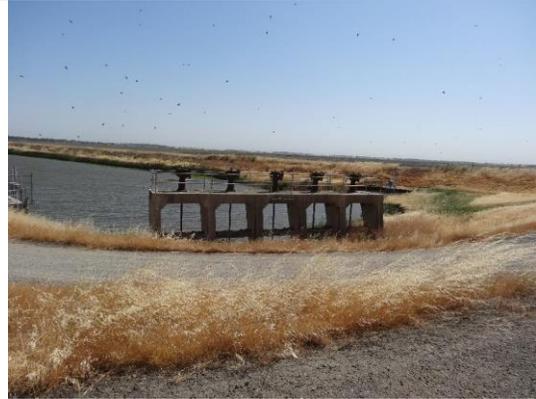
Photo 3 of 3 : UCIP\_SP\_2018\_37611\_68222.jpg

| FS_ID:37611<br>DS_ID:22388<br>EP_NO: 9396<br>Repair Type: Non-Urgent<br>Crossing Status: Found<br>UCIP Comments: Need to contact owner to determine status of structure. Notes indicate crossing has been abandoned. Owner will need to coordinate with CVFPB and DWR inspector to determine how to properly abandon.<br>FIELD_STRUCT_DESC: *ABANDONED* 4 of 5: 72-inch reinforced concrete gravity drainage pipe or culvert through the levee, 31.6 feet below the crown. Slide gate on each end. (Retention of five 72-inch pipes through the levee [HLM 0.08] authorized under Automatic Board Order (ABO) issued as Permit No. 9736, 1974 - Reclamation District No. 108 [RD0108]). [Additional Reference(s): DWR Levee Log, 1991. USACE Sacramento O&M Manual 132, October 1959, (HLM 0.08), referenced as five 6-foot by 8-foot concrete drainage culverts].<br>FS Date: 6/10/2014 | | | | | |

Concrete structure visible on landward side.

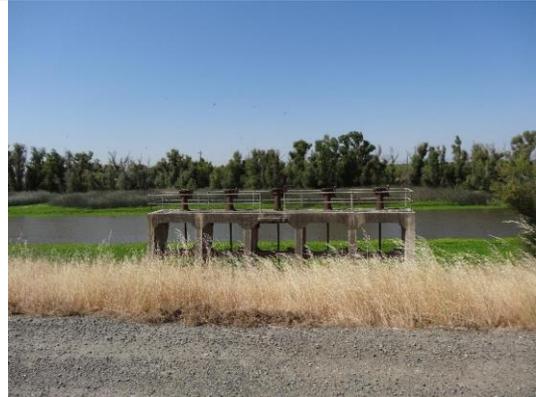
Photo 1 of 3 : UCIP\_SP\_2018\_37607\_68203.jpg

| FS_ID:37607<br>DS_ID:22389<br>EP_NO: 9396<br>Repair Type: Non-Urgent<br>Crossing Status: Found<br>UCIP Comments: Need to contact owner to determine status of structure. Notes indicate crossing has been abandoned. Owner will need to coordinate with CVFPB and DWR inspector to determine how to properly abandon.<br>FIELD_STRUCT_DESC: *ABANDONED* 5 of 5: 72-inch reinforced concrete gravity drainage pipe or culvert through the levee, 31.6 feet below the crown. Slide gate on each end. (Retention of five 72-inch pipes through the levee [HLM 0.08] authorized under Automatic Board Order (ABO) issued as Permit No. 9736, 1974 - Reclamation District No. 108 [RD0108]). [Additional Reference(s): DWR Levee Log, 1991. USACE Sacramento O&M Manual 132, October 1959, (HLM 0.08), referenced as five 6-foot by 8-foot concrete drainage culverts].<br>FS Date: 6/10/2014 | | | | | |

Concrete structure located on waterward side.

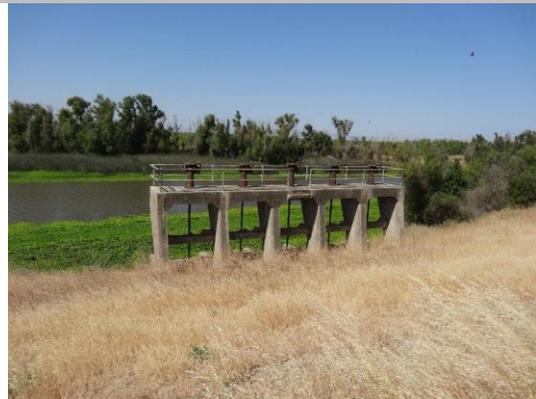
Photo 2 of 3 : UCIP\_SP\_2018\_37607\_68206.jpg

Waterward slope covered by dense vegetation.

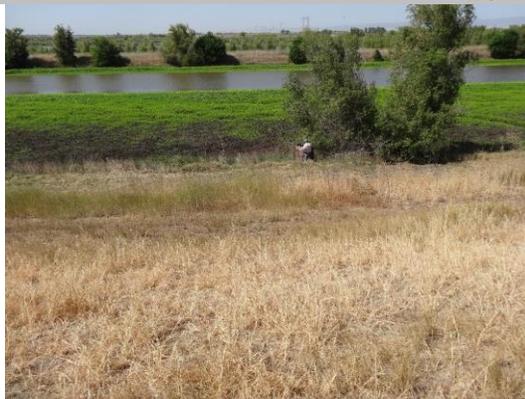
Photo 1 of 3 : UCIP\_SP\_2018\_39707\_71682.jpg

| FS_ID:39707<br>DS_ID:24875<br>EP_NO: N/A<br>Repair Type: Non-Urgent<br>Crossing Status: Indicator Found<br>UCIP Comments: No signs of pipe visible--need to contact owner to obtain permit number authorizing work. If crossing is no longer used by owner, the owner will need to coordinate with DWR Inspector and CVFPB to remove crossing according to Title 23 requirements. Dense vegetation limits the inspector's visibility to identify signs of pipe failure (leaks) along the slope. Recommend removing vegetation along pipe alignment to conduct proper inspection of structure.<br>FIELD_STRUCT_DESC: Corrugated metal pipe (CMP) riser on the waterside (WS). Riser is filled with trash and debris. Unable to determine if a crossing exists at this location. This riser was field discovered.<br>FS Date: 3/18/2014 | | | | | |

View of waterward side.

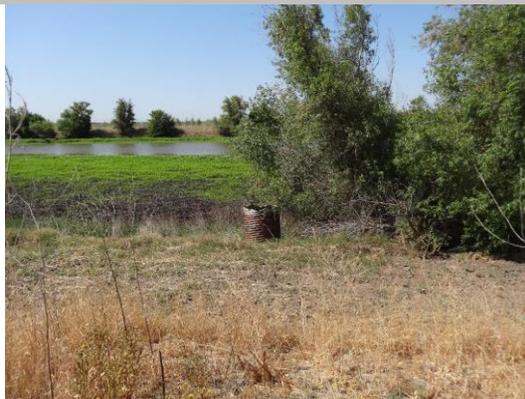
Photo 2 of 3 : UCIP\_SP\_2018\_39707\_71681.jpg

CMP riser located on waterward toe--2/3 filled with soil and trash.

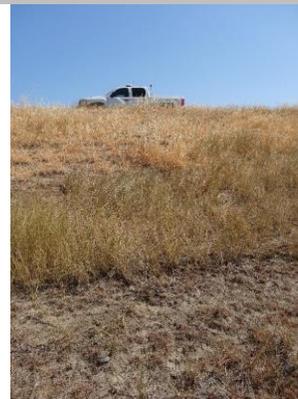
Photo 3 of 3 : UCIP\_SP\_2018\_39707\_71680.jpg

| FS_ID:39707<br>DS_ID:24875<br>EP_NO: N/A<br>Repair Type: Non-Urgent<br>Crossing Status: Indicator Found<br>UCIP Comments: No signs of pipe visible--need to contact owner to obtain permit number authorizing work. If crossing is no longer used by owner, the owner will need to coordinate with DWR Inspector and CVFPB to remove crossing according to Title 23 requirements. Dense vegetation limits the inspector's visibility to identify signs of pipe failure (leaks) along the slope. Recommend removing vegetation along pipe alignment to conduct proper inspection of structure.<br>FIELD_STRUCT_DESC: Corrugated metal pipe (CMP) riser on the waterside (WS). Riser is filled with trash and debris. Unable to determine if a crossing exists at this location. This riser was field discovered.<br>FS Date: 3/18/2014 | | | | | |

View of waterward slope.

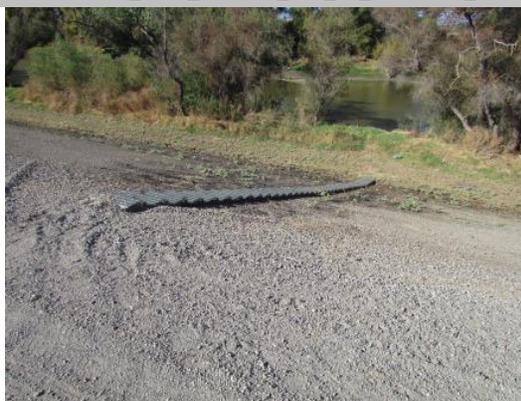
Photo 1 of 1 : SP\_2018\_RD0108\_203\_16\_20180306\_00003.jpg

| Department of Fish and Game staff is using stairway to access their monitoring site. Unable to verify permit. | | | | | |

View of a steel stairway on WS slope. Fall 2016 inspection.

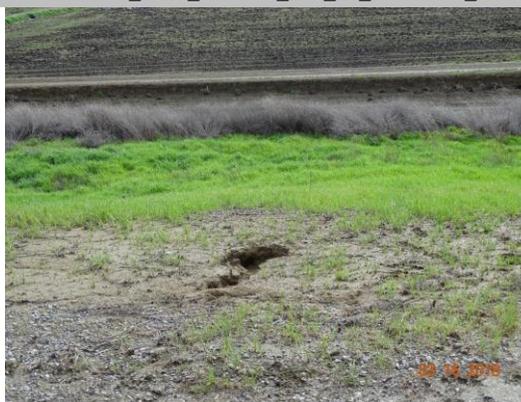
Photo 1 of 1 : SP\_2018\_RD0108\_203\_21\_20180316\_00051.jpg

| Minor erosion on landside slope. | | | | | |

View of erosion on landside slope. Spring 2018.

| E2 : Schedule repair of erosion site prior to the next inspection. | | | | | |

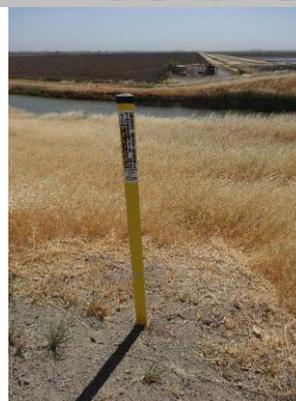
Photo 1 of 3 : UCIP\_SP\_2018\_39717\_71705.jpg

| FS_ID:39717<br>DS_ID:24876<br>EP_NO: N/A<br>Repair Type: Non-Urgent<br>Crossing Status: Indicator Found<br>UCIP Comments: Need to contact owner to determine additional details of crossing.<br>FIELD_STRUCT_DESC: Natural gas pipeline of an unknown size or material slightly angled through the levee, at an unknown depth.<br>Markers on both sides of the levee. Gas station located across the canal on the landside (LS). This crossing was field discovered.<br>FS Date: 3/18/2014 | | | | | |

View of marker visible on shoulder.

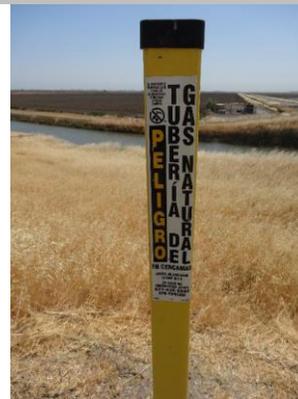
Photo 2 of 3 : UCIP\_SP\_2018\_39717\_71704.jpg

| LM Start | 11.24 | Rating ** | M | Issue No. | 42 (cont) |
|--|---|---|---|---|---|
| FS_ID:39717<br>DS_ID:24876<br>EP_NO: N/A<br>Repair Type: Non-Urgent<br>Crossing Status: Indicator Found<br>UCIP Comments: Need to contact owner to determine additional details of crossing.<br>FIELD_STRUCT_DESC: Natural gas pipeline of an unknown size or material slightly angled through the levee, at an unknown depth.<br>Markers on both sides of the levee. Gas station located across the canal on the landside (LS). This crossing was field discovered.<br>FS Date: 3/18/2014 | | | | | |

Owner contact information listed on marker.

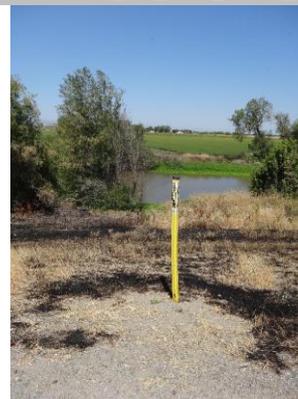
Photo 3 of 3 : UCIP\_SP\_2018\_39717\_71703.jpg

Marker visible on waterward side.

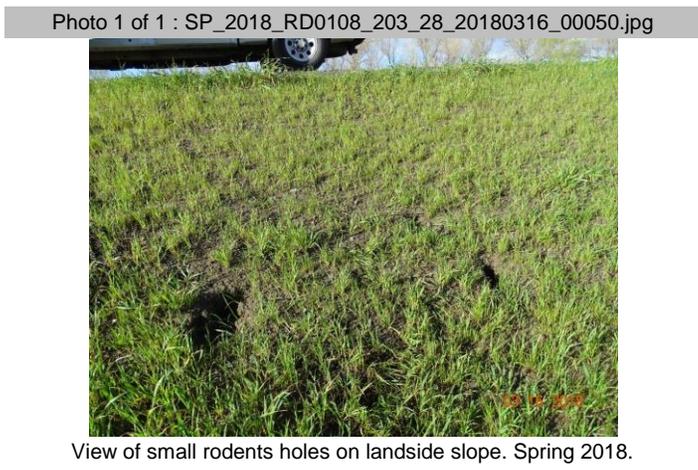
| Small rodent holes on landside slope. Recommend monitoring for future activity. | | | | | |

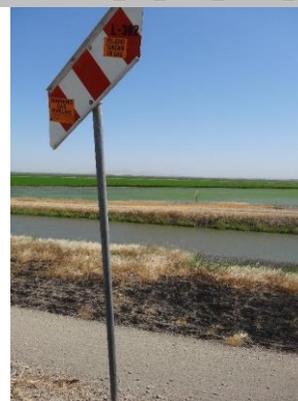
Photo 1 of 3 : UCIP\_SP\_2018\_37623\_68246.jpg

| FS_ID:37623<br>DS_ID:17942<br>EP_NO: 3800<br>Repair Type: Non-Urgent<br>Crossing Status: Indicator Found<br>UCIP Comments: Need to contact owner--marker missing on waterward side.<br>FIELD_STRUCT_DESC: 20-inch concrete encased steel natural gas pipeline through the levee, 3 feet below the crown. Crossing appears to be angled through the levee. Small rock revetment on the waterside (WS) slope, unable to locate. Gas well approximately 1000 feet off the landside (LS) toe. (Plans to construct and maintain a 20-inch gas line across the Sacramento River authorized under Permit No. 3800, 1961 - Pacific Gas and Electric Company [PG&E]). [Additional Reference(s): DWR Levee Log, 1991].<br>FS Date: 6/10/2014 | | | | | |

Marker visible on landward side.

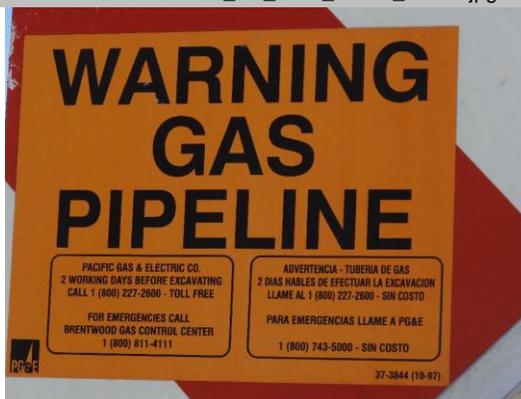
Photo 2 of 3 : UCIP\_SP\_2018\_37623\_68245.jpg

| FS_ID:37623<br>DS_ID:17942<br>EP_NO: 3800<br>Repair Type: Non-Urgent<br>Crossing Status: Indicator Found<br>UCIP Comments: Need to contact owner--marker missing on waterward side.<br>FIELD_STRUCT_DESC: 20-inch concrete encased steel natural gas pipeline through the levee, 3 feet below the crown. Crossing appears to be angled through the levee. Small rock revetment on the waterside (WS) slope, unable to locate. Gas well approximately 1000 feet off the landside (LS) toe. (Plans to construct and maintain a 20-inch gas line across the Sacramento River authorized under Permit No. 3800, 1961 - Pacific Gas and Electric Company [PG&E]). [Additional Reference(s): DWR Levee Log, 1991].<br>FS Date: 6/10/2014 | | | | | |

Contact information for gas line going through levee.

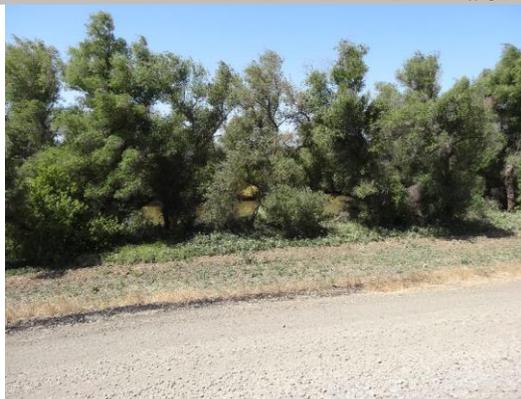
Photo 3 of 3 : UCIP\_SP\_2018\_37623\_68244.jpg

View of waterward side. No marker visible on waterward side.

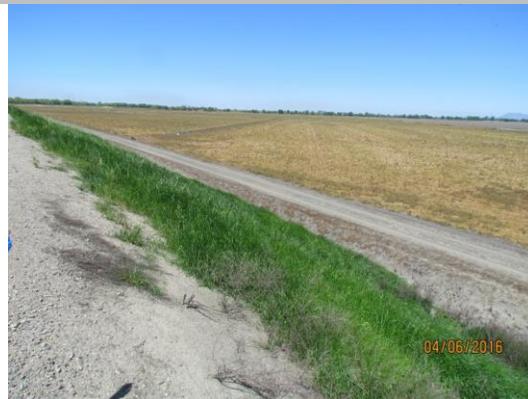
Photo 1 of 1 : SP\_2018\_RD0108\_203\_6\_20180306\_00001.jpg

| Ditch is at the toe of the levee. | | | | | |

View of the ditch at the toe of the levee on the landward side looking upstream. Spring 2016.

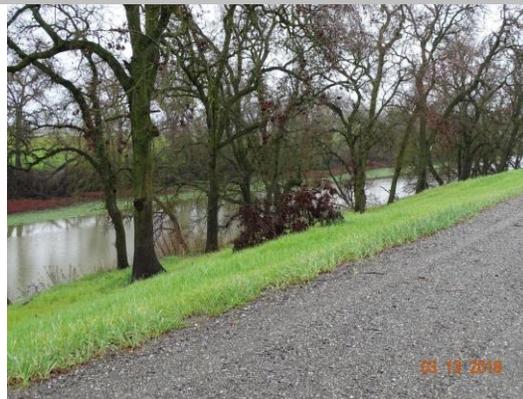
Photo 1 of 1 : SP\_2018\_RD0108\_590\_1\_20180313\_00003.jpg

| Fallen tree branch on waterside slope. | | | | | |

View of tree branch on the waterside slope. Spring 2018.
